MACOMB COMMUNITY COLLEGE
MTEC and EAST CAMPUS

FACILITIES ASSESSMENT AND
DEFERRED MAINTENANCE
CAPITAL PLANNING REPORT

IDS Project No. 21195-4000

November 2023

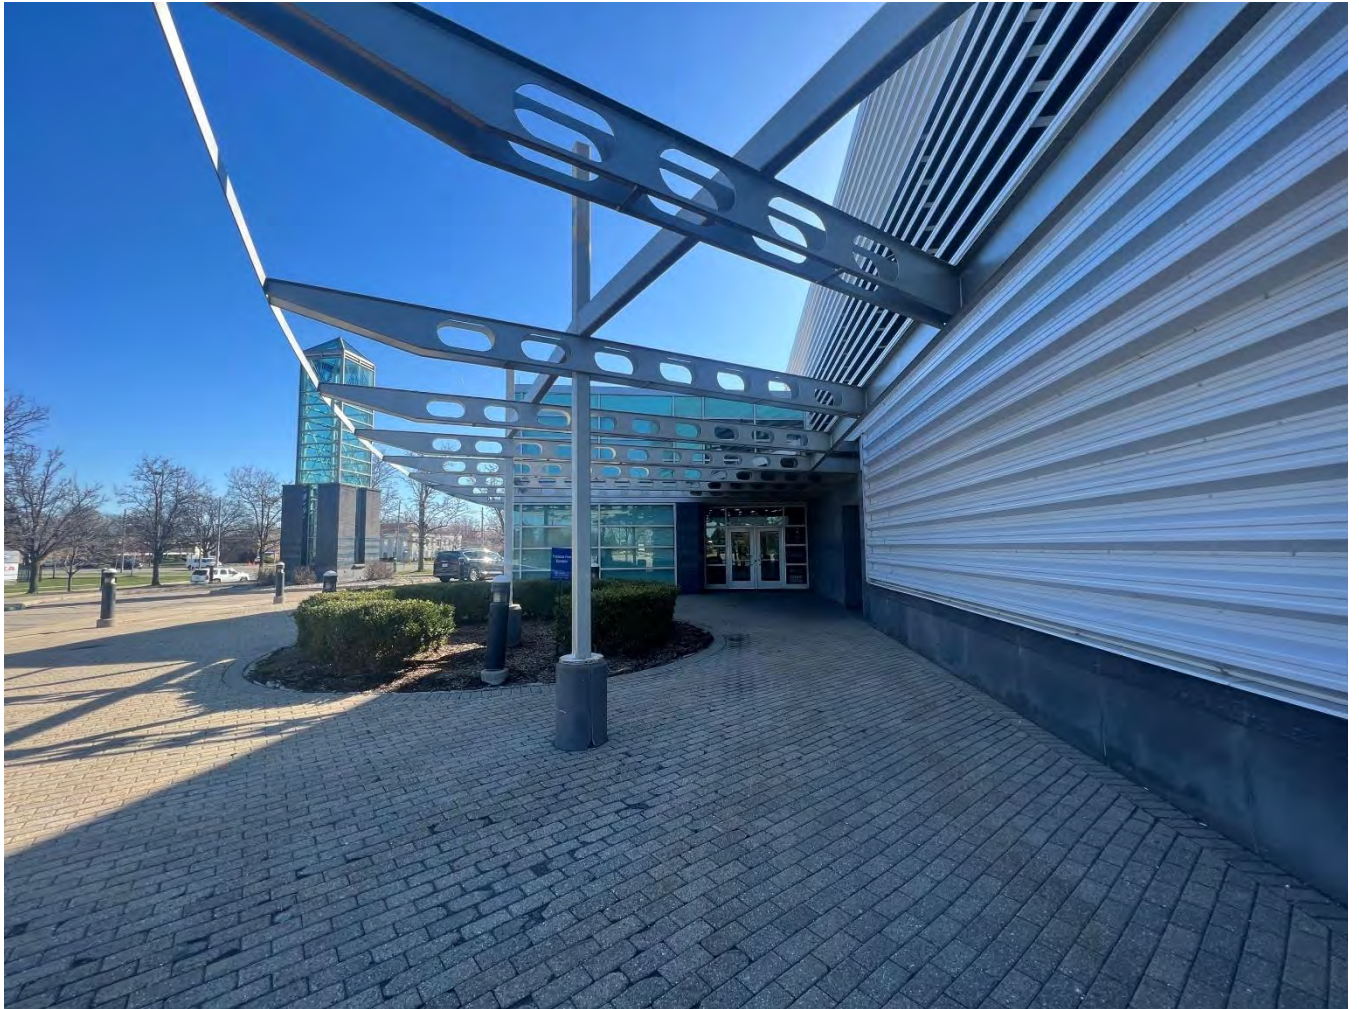
MTEC

- Johns Manville single-ply roof installed in 2001. Roof warranty expired in 2016. Roof should be scheduled for replacement.

- HVAC system is original from 2001 and has reached its useful life. Major HVAC equipment should be scheduled for replacement.

- Plumbing systems are original from 2001.

- Full suppression system is original from 2001.

- Temperature controls are original from 2001. Remove the existing Continuum (Andover) controls and replace with Tridium (Honeywell).

- Electrical equipment was installed in 2001 and is good condition.

- Some classroom lighting has been replaced with LED light fixtures, but the controls have not been updated to the current ASHRAE standards. These areas are considered to be included in the full replacement of lighting/controls.

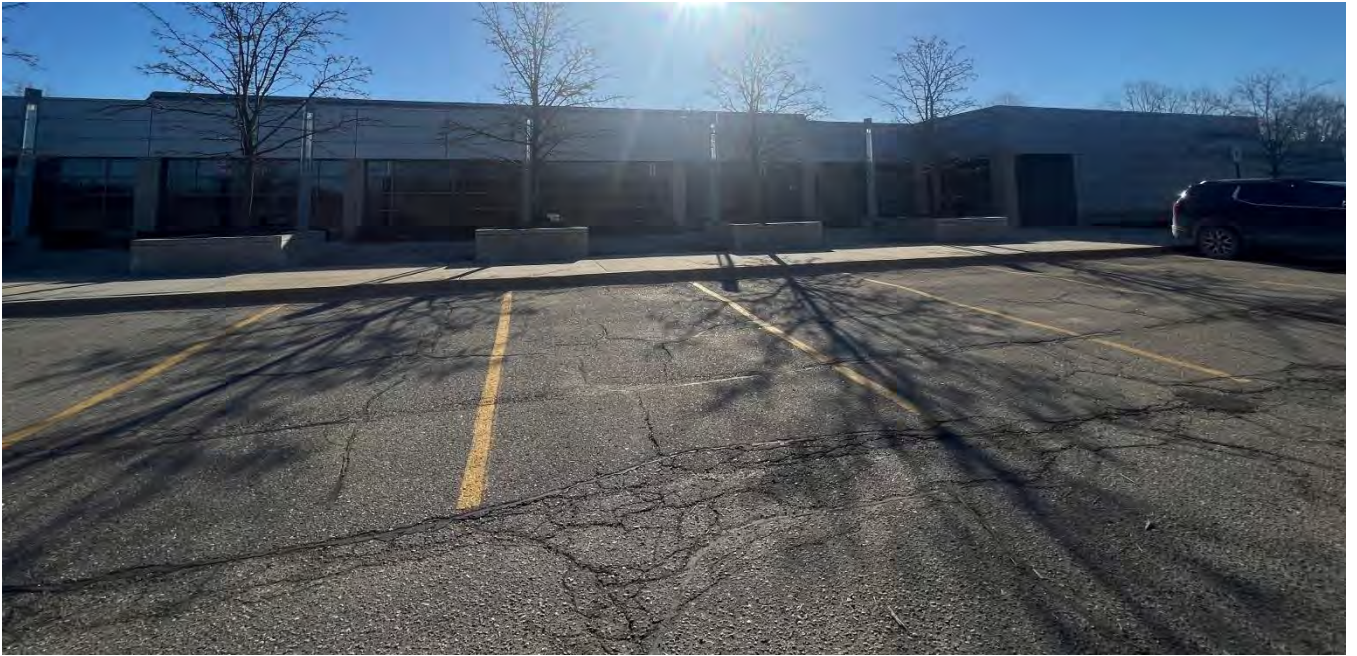
CRIMINAL JUSTICE TRAINING CENTER

- Johns Manville EPDM roof over criminal justice is original, installed in 2002 and should be replaced.
- Johns Manville EPDM roof replaced in 2013 (Fire). Warranty expires in 2028.

- Original 1994 Fire Training Center HVAC system was updated during the 2002 Criminal Justice Training Center addition.
- The 2006 Emergency Training Center addition was provided with all new HVAC system.

- Domestic water heaters were installed/upgraded similar to HVAC system.

- 1994 Fire Training Center and the 2002 Criminal Justice Center are not sprinklered.
- The 2006 Emergency Training Center addition is provided with a wet type protection system throughout.
- The three (3) rooftop HVAC unit and HVAC unit serving the gun range should be scheduled for replacement.

- Replace existing Desigo (Siemens) BAS controls with new Tridium (Honeywell) system.

- Electrical equipment appears original to the construction of the 2007 building and 2007 addition.

- The exit signs are LED.
