### MACOMB COMMUNITY COLLEGE CENTER CAMPUS

FACILITIES ASSESSMENT AND DEFERRED MAINTENANCE CAPITAL PLANNING REPORT

IDS Project No. 21195-4000

November 2023

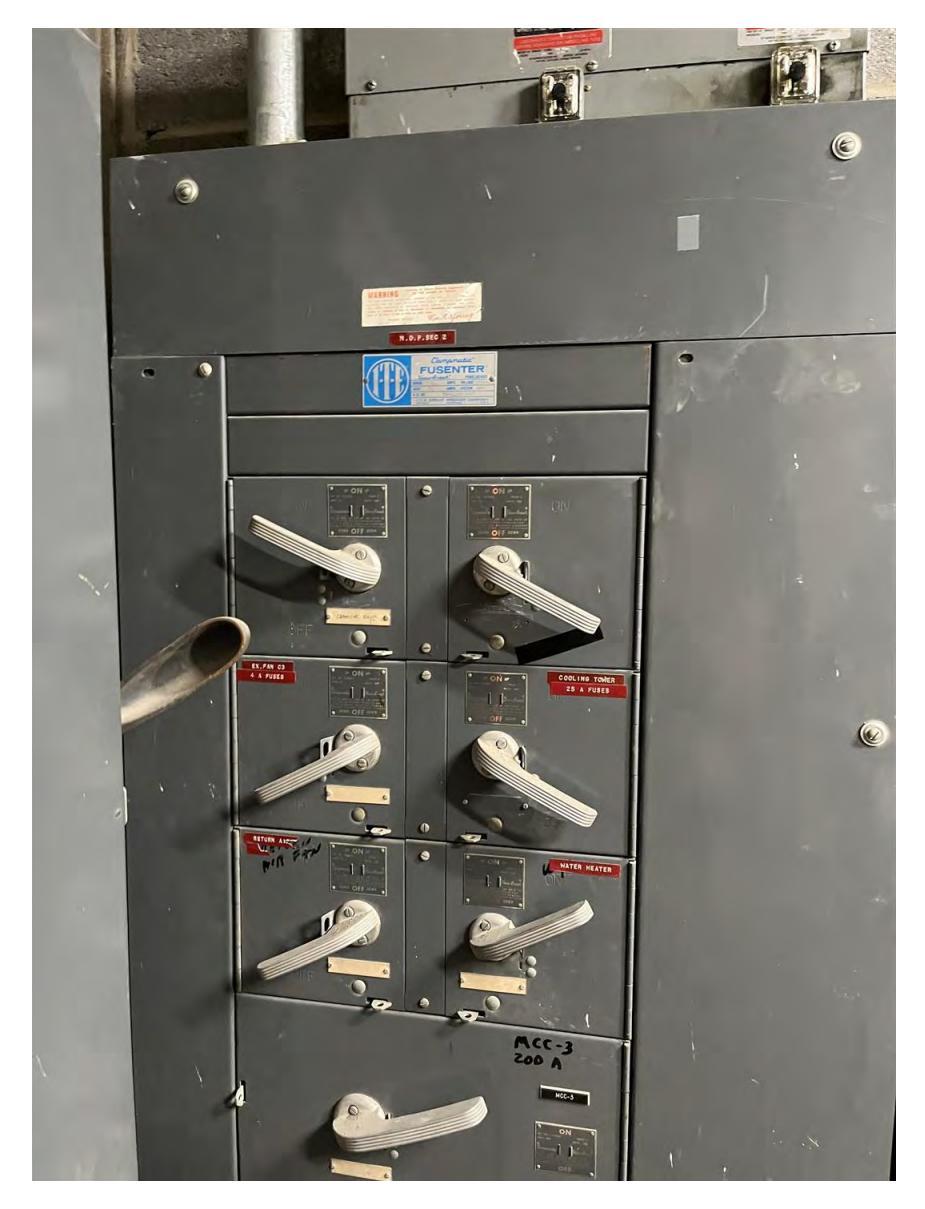
Existing Distribution Equipment

Power S	ystems								-					_	
			Main electrical equipment from 1993 addition. This equipment is nearing the end of its life												
1	Power Systems	Electrical Room C171	expectancy and should be considered for replacement in the next renovation (MV	1	LS					\$415,000.00	\$ 415,000	) <b>\$</b>	415,000	\$	601,750
			switches, I ransformer, main switchboard, distribution panels and branch panelboards).									╉───			
2	Power Systems	Electrical Room C104	Legacy equipment from the original 1968 building is passed it's life expectancy and should be replaced with the past repovetion	1	LS					\$121,000.00	\$ 121,000	) <b>\$</b>	121,000	\$	175,450
			Existing arc flash labels are generic type and do not indicate incident energy boundaries									+			
3	Power Systems	General	available fault current, etc., While not required by code, it is recommended to update	1	LS					\$ 4.000.00	\$ 4.000	) <b>\$</b>	4.000	\$	5.800

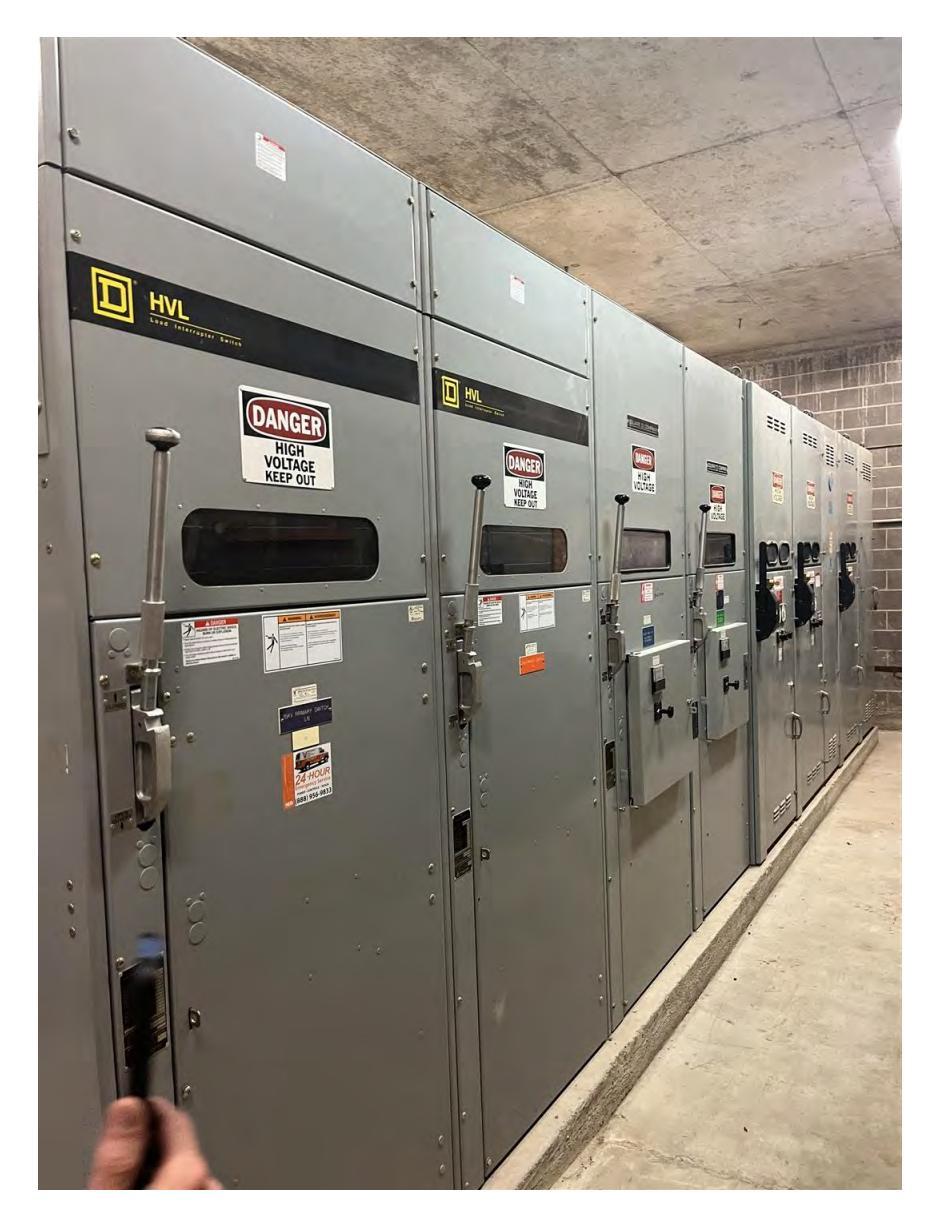
Existing Switchgear

3	Power Systems	Main Electrical Room	Pullbox was observed with partially open cover and exposed wiring. This is a code violation. It is recommended this be corrected.	1	LS					\$ 500.00	\$ 500	\$ 500	\$ 725
4	Power Systems	General	Existing arc flash labels are generic type and do not indicate incident energy boundaries, available fault current, etc While not required by code, it is recommended to update power system study and labeling to match that of Building CA.	1	LS					\$ 4,000.00	\$ 4,000	\$ 4,000	\$ 5,800
5	Power Systems	General	The electrical equipment had no indication of recent maintenance or testing. The labels indicate the latest testing was done in 2013 on the equipment. Testing / maintenance is recommended at regular intervals.	1	LS					\$ 10,000.00	\$ 10,000	\$ 10,000	\$ 14,500
Lighting	System									-		-	
1	Lighting System	General	Lighting consists of fluorescent fixtures containing T12 lamps. Lighting should be replaced throughout with LED.	1,562	SF					\$ 8.00	\$ 12,496	\$ 12,496	\$ 18,119
