MACOMB COMMUNITY COLLEGE
MTEC and EAST CAMPUS

FACILITIES ASSESSMENT AND
DEFERRED MAINTENANCE
CAPITAL PLANNING REPORT

IDS Project No. 21195-4000

November 2023

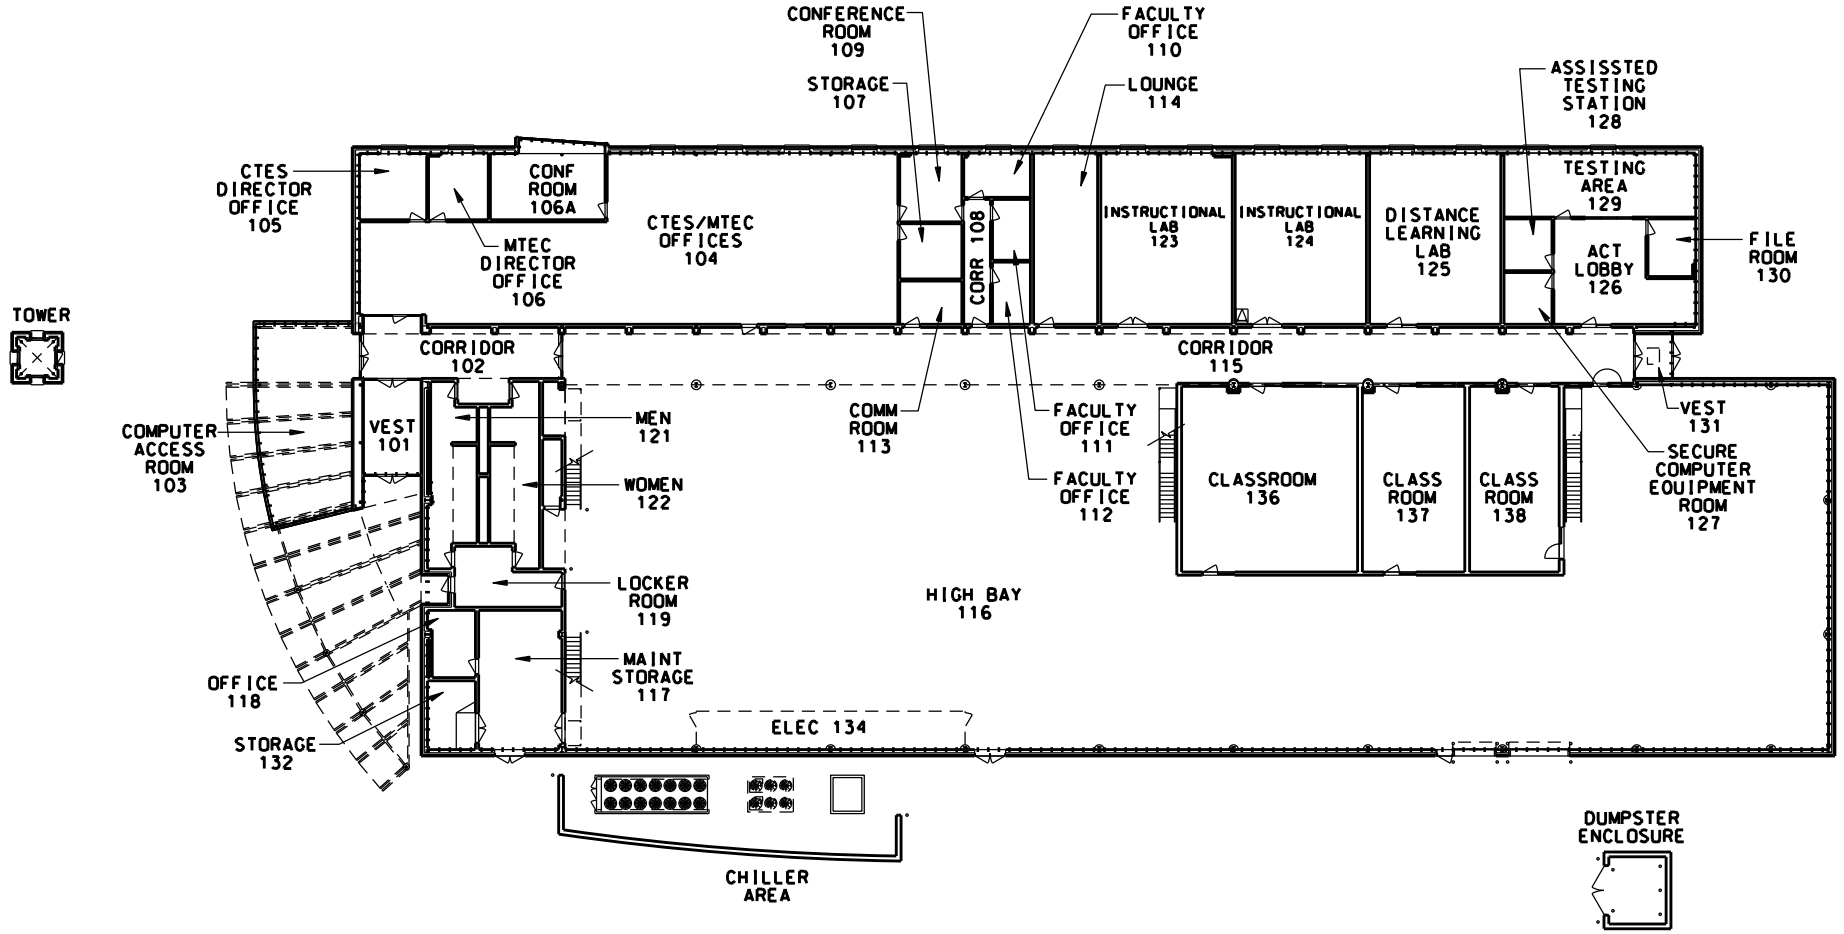
- Temperature controls are original from 2001. Remove the existing Continuum (Andover) controls and replace with Tridium (Honeywell).

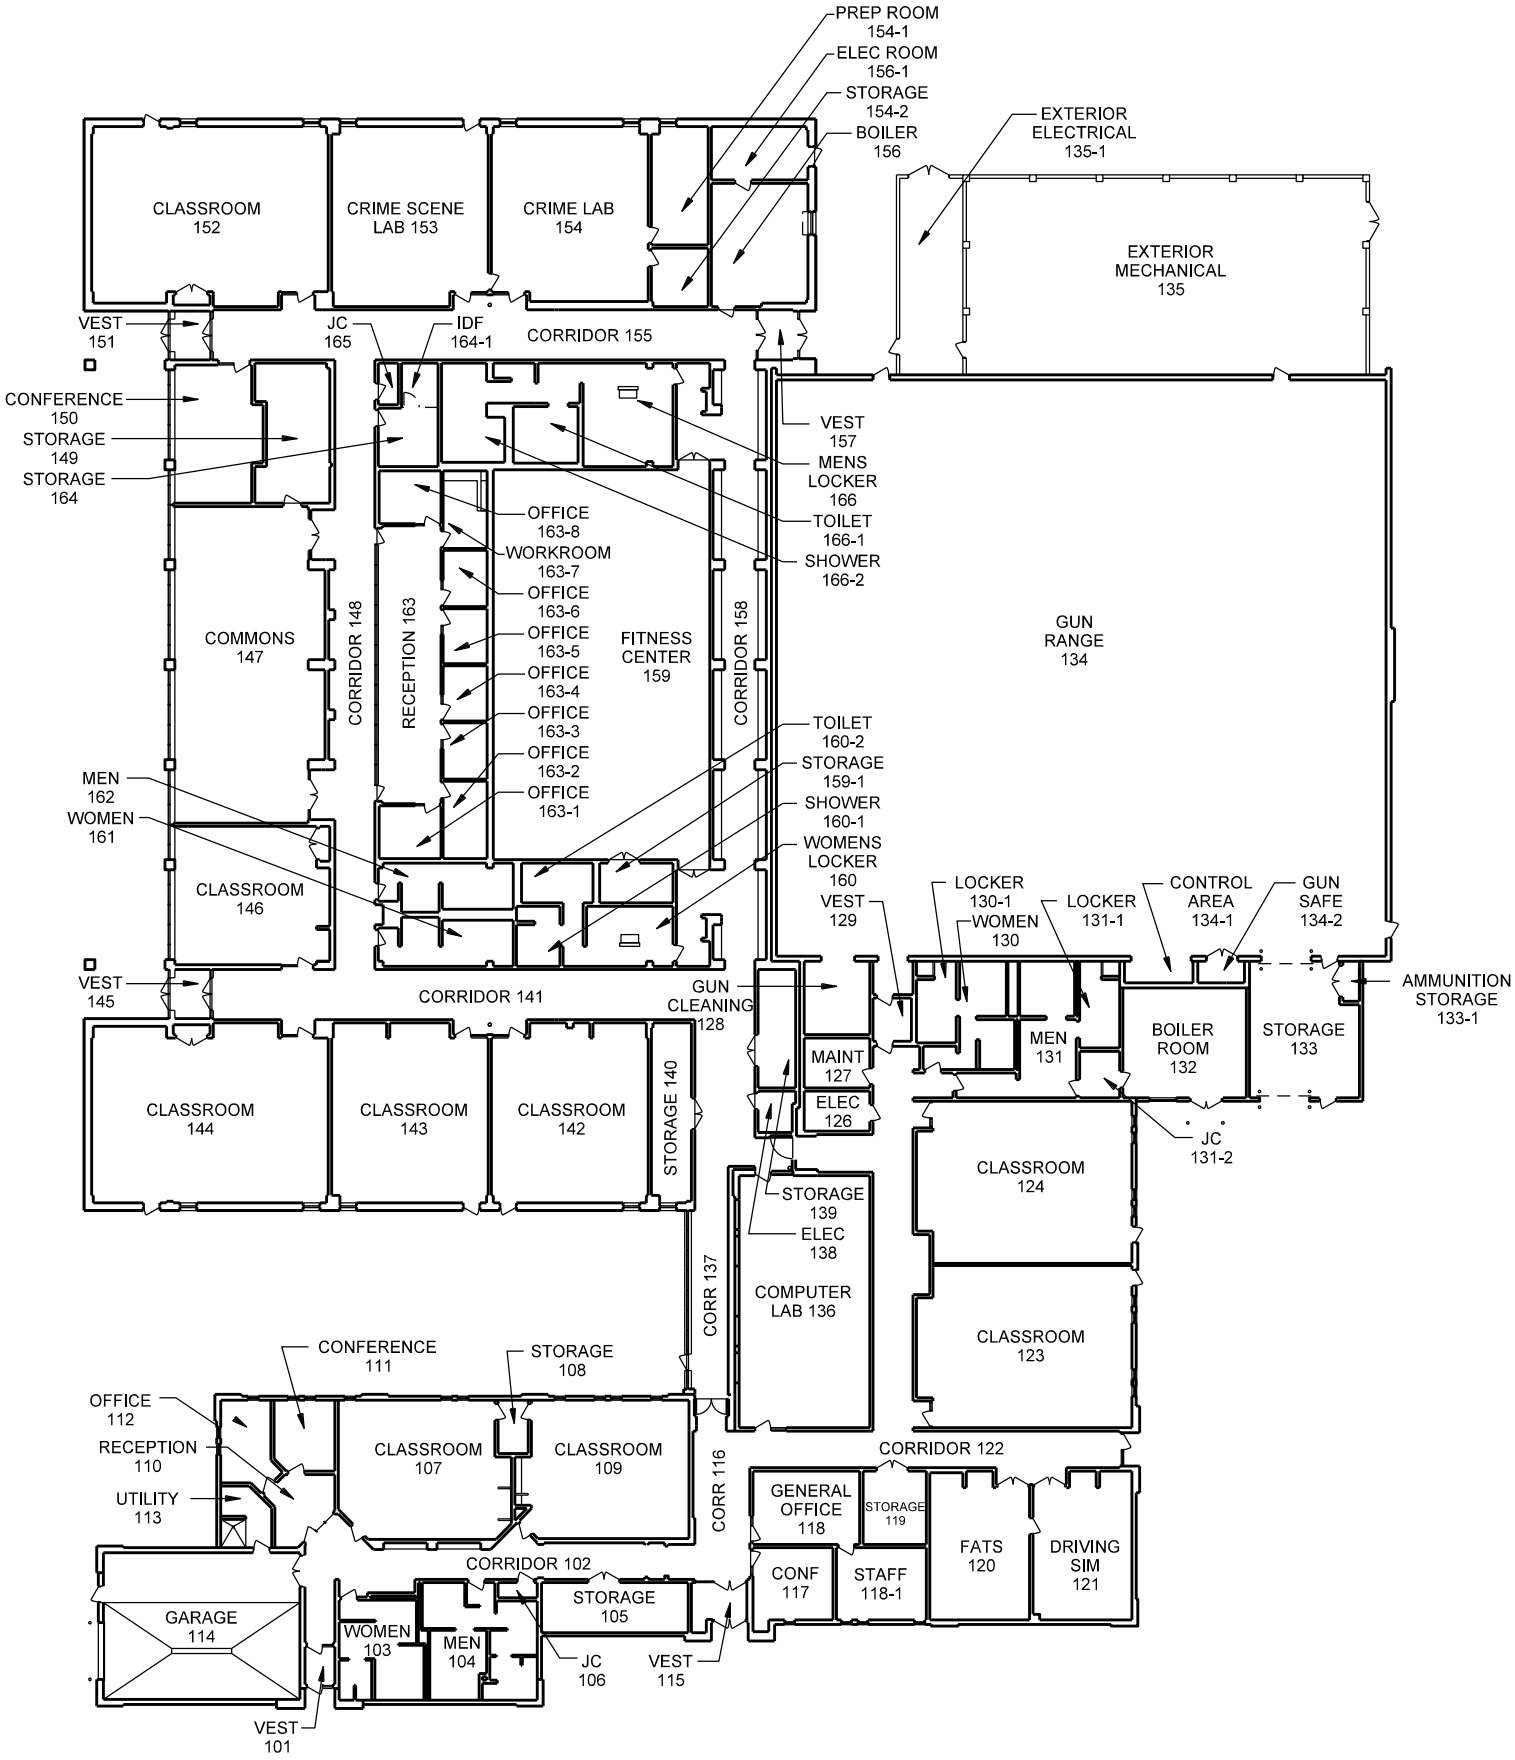
- Replace existing Desigo (Siemens) BAS controls with new Tridium (Honeywell) system.
