### MACOMB COMMUNITY COLLEGE CENTER CAMPUS

FACILITIES ASSESSMENT AND DEFERRED MAINTENANCE CAPITAL PLANNING REPORT

IDS Project No. 21195-4000

November 2023

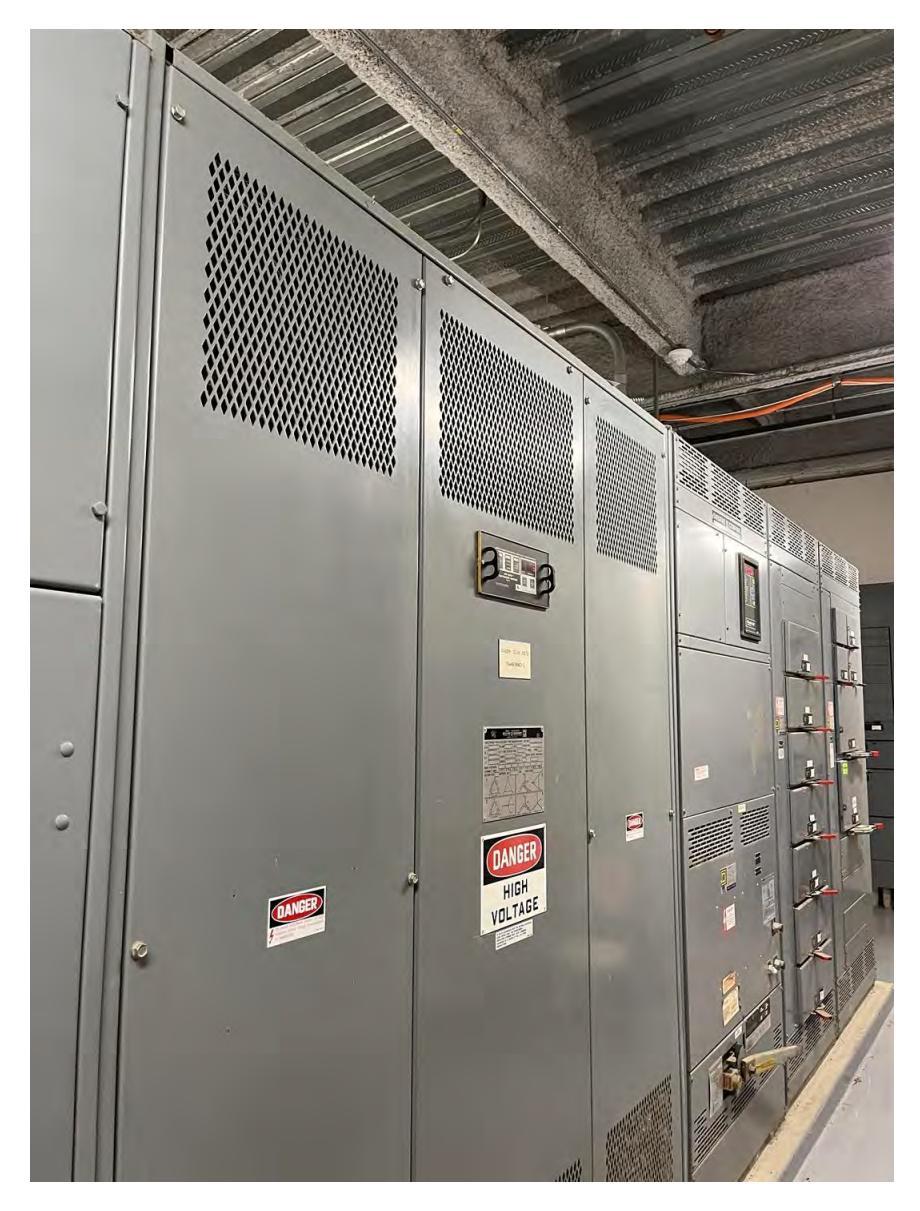
Existing Substation

Power S	ystems								-					_	
			Main electrical equipment from 1993 addition. This equipment is nearing the end of its life												
1	Power Systems	Electrical Room C171	expectancy and should be considered for replacement in the next renovation (MV	1	LS					\$415,000.00	\$ 415,000	) <b>\$</b>	415,000	\$	601,750
			switches, I ransformer, main switchboard, distribution panels and branch panelboards).									╉───			
2	Power Systems	Electrical Room C104	Legacy equipment from the original 1968 building is passed it's life expectancy and should be replaced with the past repovetion	1	LS					\$121,000.00	\$ 121,000	) <b>\$</b>	121,000	\$	175,450
			Existing arc flash labels are generic type and do not indicate incident energy boundaries									+			
3	Power Systems	General	available fault current, etc., While not required by code, it is recommended to update	1	LS					\$ 4.000.00	\$ 4.000	) <b>\$</b>	4.000	\$	5.800

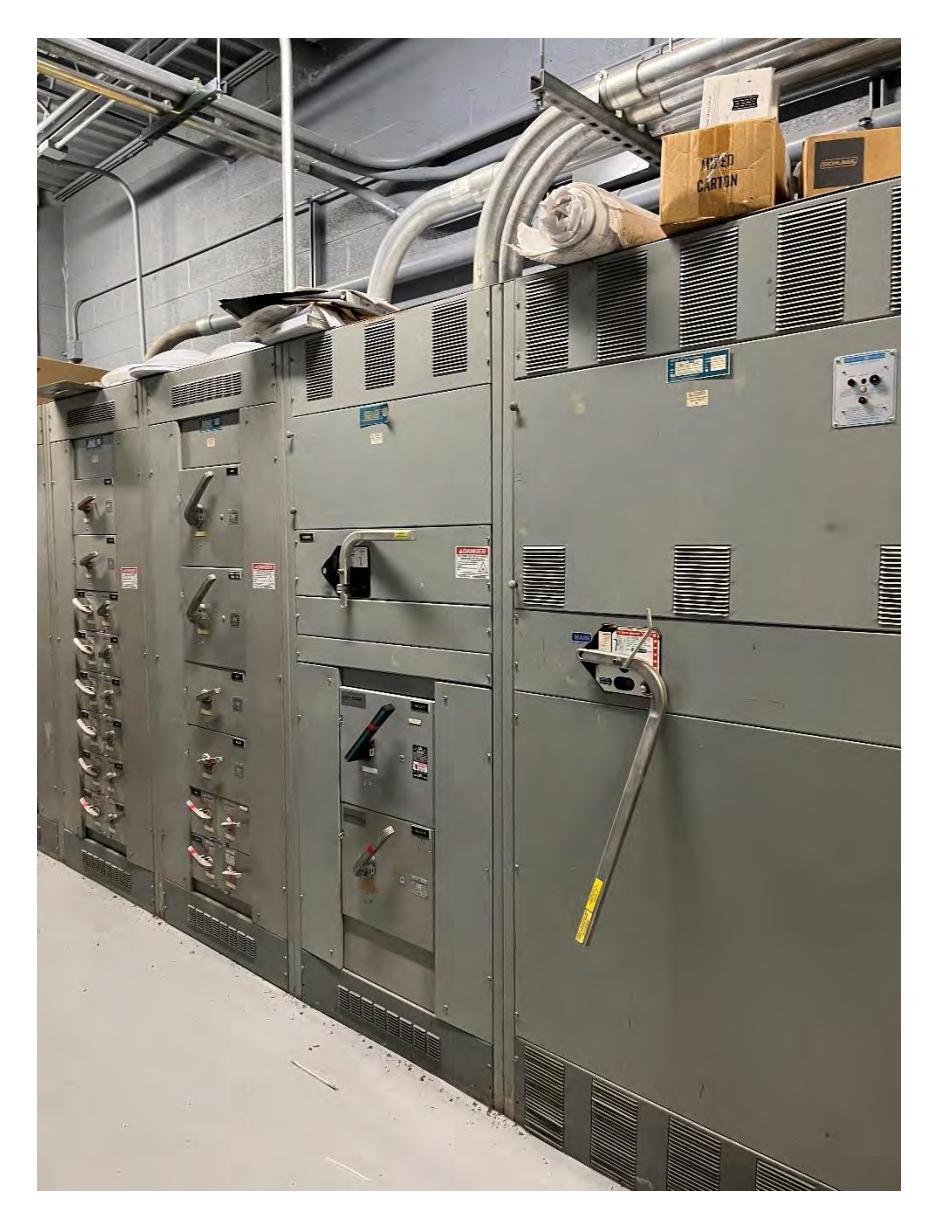
Existing Switchboard

Plumbin	g System												
1	Plumbing System	Boiler Room CL-116	Water heater and flue damaged from water and need to be replaced.	1	LS			\$ 4,275.00	\$ 4,275			\$ 4,27	5 \$ 6,199
Power S	ystems										-		
1	Power Systems	General	A majority of electrical distribution equipment is 41 years of age and is nearing end of expected useful life. Replacement is recommended in next major renovation.	30,400	SF					\$ 16.00	\$ 486,400	\$ 486,40	0 \$ 705,280
2	Power Systems	General	Existing arc flash labels are generic type and do not indicate incident energy boundaries, available fault current, etc While not required by code, it is recommended to update power system study and labeling to match that of building CA.	1	LS					\$ 8,000.00	\$ 8,000	\$ 8,00	0 \$ 11,600
							\$ 37,500		\$ 4,275		\$ 494,400	\$ 536,17	5 \$ 777,454
